Manhole Inspection Summary

Manhole # S25C__020MH

Insp Date: **4/27/09 8:37 AM**

Location Address: **316 CALHOUN-CAREY**

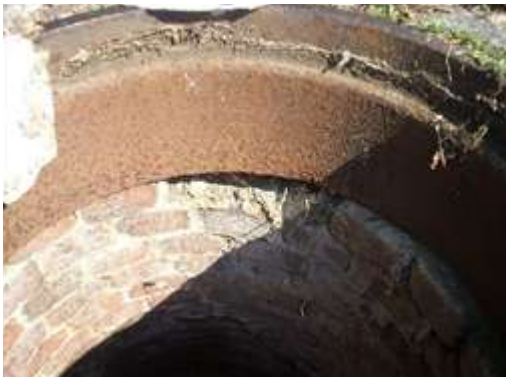
Defect 5

Condition: ☐ Sound ☒ **Cracked** ☐ Root Intrusion ☐ Loose Brick ☒ **Deteriorated**

DETERIORATED CORBEL

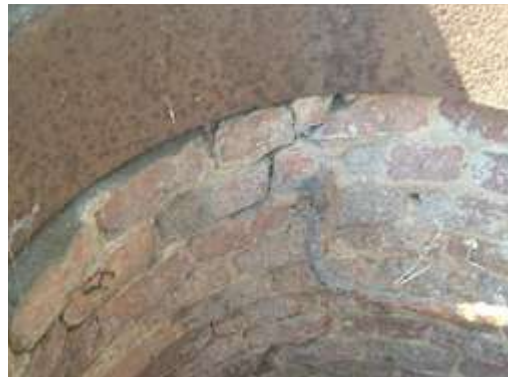
Defect 4

CRACKED CORBEL

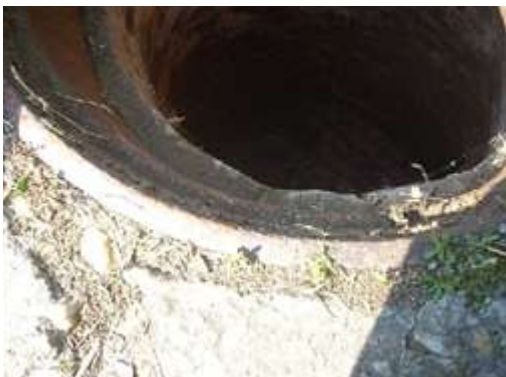
Defect 3

Frame Offset: **2** (in.) Condition: ☒ Sound ☐ Cracked ☐ Leaks

FRAME OFFSET

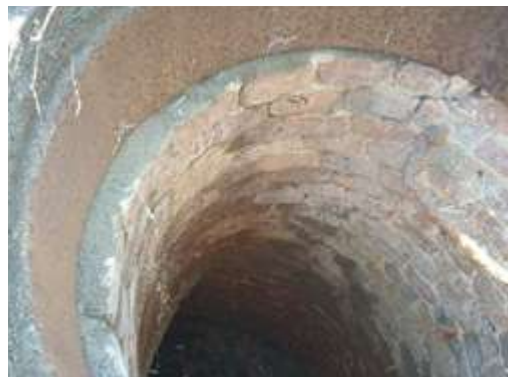
Defect 2

Infiltration: ☐ None ☐ Joint ☐ Cracks ☐ Mortar ☐ Roots ☒ **Wall**

INFILTRATION EVIDENCE, CORBEL WALL

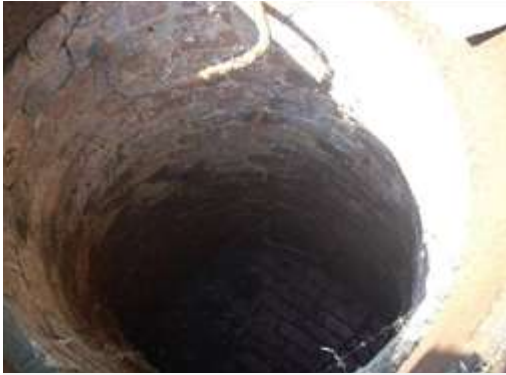
Defect 1

Steps Count: **2** Missing: **2** ☒ **Corroded**

CORRODED AND MISSING STEPS

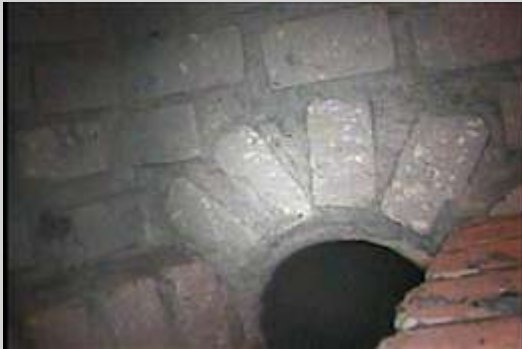
12 O'Clock Outflow

8 in. Circular Gravity Sewer
Pipe Out @ 12 O'Clock

Pipe Height: **8.4** (in.) Rod and Bar (Angled)
Pipe Material: **Clay** ☐ Pipe Lined
Invert Depth: **7.51** (ft.) Flow Characteristics: **Slow**
Deposits: ☒ None ☐ Mud ☐ Sludge ☐ Debris ☐ Grease
Silt Depth: (in.) Deposits Extent:
Infiltration: **None** Pipe Seal Cond: **Sound**

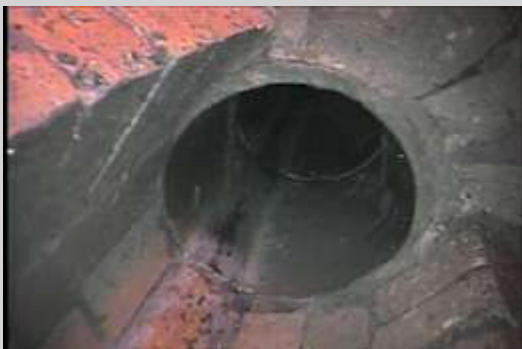
3 O'Clock Inflow

8 in. Circular Gravity Sewer
Pipe In @ 3 O'Clock

Pipe Height: **7.2** (in.) Rod and Bar (Angled)
Pipe Material: **Clay** ☐ Pipe Lined
Invert Depth: **7.38** (ft.) Flow Characteristics: **None**
Deposits: ☒ None ☐ Mud ☐ Sludge ☐ Debris ☐ Grease
Silt Depth: (in.) Deposits Extent:
Infiltration: **None** Pipe Seal Cond: **Sound**

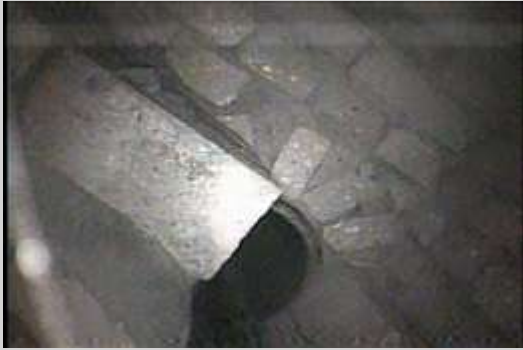
6 O'Clock Inflow

8 in. Circular Gravity Sewer
Pipe In @ 6 O'Clock

Infiltration: **None** Pipe Seal Cond: **Sound**
